**EPA REGION 6
AIR INSPECTION REPORT**

FRS #: 110000504268 Inspection Dates: **October 10-12, 2012**
AFS #: 48-201-00153
Type of inspection: Clean Air Act, Partial Compliance Evaluation
Company Name: **INTERCONTINENTAL TERMINALS COMPANY LLC**
Facility Name: **INTERCONTINENTAL TERMINALS DEER PARK TERMINAL**
Physical Location: 1943 Independence Parkway South (also known as Battleground Road)
Deer Park, Texas 77536
Mailing Address: P.O. Box 698
Deer Park, Texas 77536-0698
County/Parish: **Harris County**
Reg. Programs: **SIP, Title V, MACT, NESHAP, and NSPS**
SIC Code: 4226 and 4953

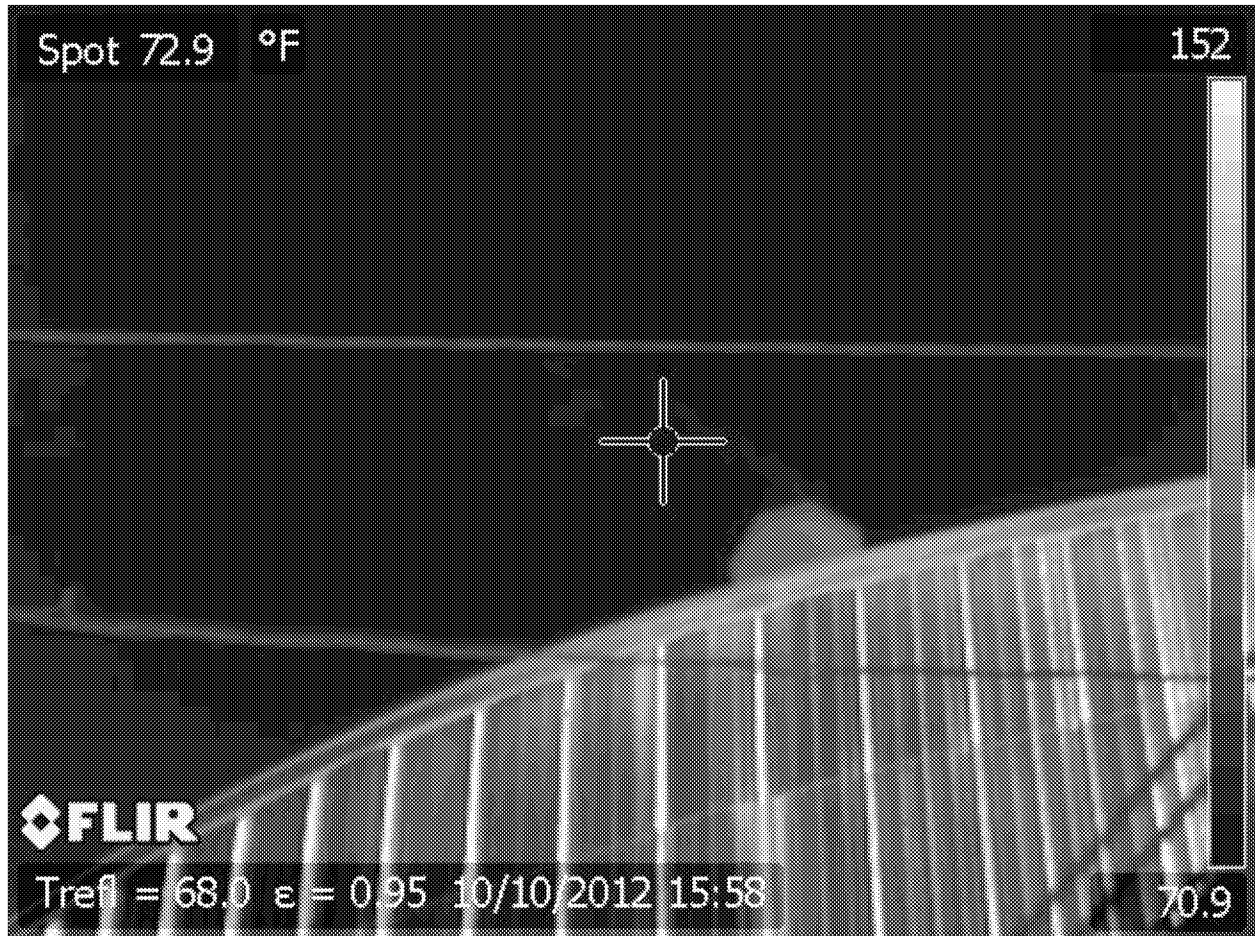
Photo 1

Tank 80-9, IR Image Showing Emission in Automatic Mode from Vent on Roof of Insulated Tank. Picture taken by Cary Secrest at 15:58 on October 10, 2012 (IR_0429).

A list of all tanks and other emissions sources that were observed during the IR camera/PID survey, including inspection observations, PID survey times, IR camera video and image file names, and information about each observed tank is included as Attachment 9. Cary conducted the IR camera monitoring and I conducted the PID monitoring. Attachment 10 is the response from ITC Deer Park after the inspection, received October 29, 2012, which includes VOC vapor pressure analysis results and the records for the most recent external and internal IFR tanks inspections (as applicable), for the above noted tanks. I detected elevated PID readings downwind from Tanks 80-7, 80-9 on October 10, 2012. An IR camera photo taken by Cary and included as Attachment 7 shows emissions detected in auto coming from a vent on the roof of Tank 80-9.

3. IR camera imaging of fixed roof tanks 80-9, 80-12, 160-1, 160-2 and 160-3 indicates that the tanks' emissions may not be consistent with the VOC limits or permit application representations of Permit 1078. The tanks were not being filled or drawn down during the IR camera imaging. The hourly emissions limitation for these tanks in the maximum allowable emissions rate table of Permit 1078 is for tank working loss emissions. Permit 1078 application emissions representations dated September 29, 2004 for normal breathing losses from 37 fixed roof tanks in No. 6 fuel oil service is 0.468 lbs/hr (see Attachment 13). The representations indicate the maximum normal No. 6 fuel oil breathing losses is for a storage scenario that includes 12 fixed roof tanks with a 80,000 to 100,000 barrel capacity in service, and no fixed roof tanks with a 160,000 barrel capacity. A follow up clarification from ITC Deer Park should be requested about how storage of No. 6 fuel oil is authorized in 160,000 barrel fixed roof tanks. Attachment 10 indicates that the true VOC vapor pressures for the materials stored in these tanks was less than 0.5 psi, which is the maximum allowed without vent controls for fixed roof tanks with an 80,000 or 160,000 barrel capacity. The location in the tanks where the samples were taken should be requested, since a sample collected from the bottom of a tank may not be consistent with the material near the top of the tank. Exceeding permit application emissions representations would be a violation of 30 TAC §116.116(b)(1)(C).
